THE NDOLA ACCIDENT

A theory as to the cause of the accident

Facts not accounted for and not known to the public

On the night between the 17th and the 18th September 1961 an airplane crashed near Ndola in Northern Rhodesia (present day Zambia). The plane — a DC-6B owned and operated by the Swedish charter company Transair — carried 16 persons including the crew. None of them survived. One of the passengers was Dag Hammarskjöld, Secretary General of the United Nations.

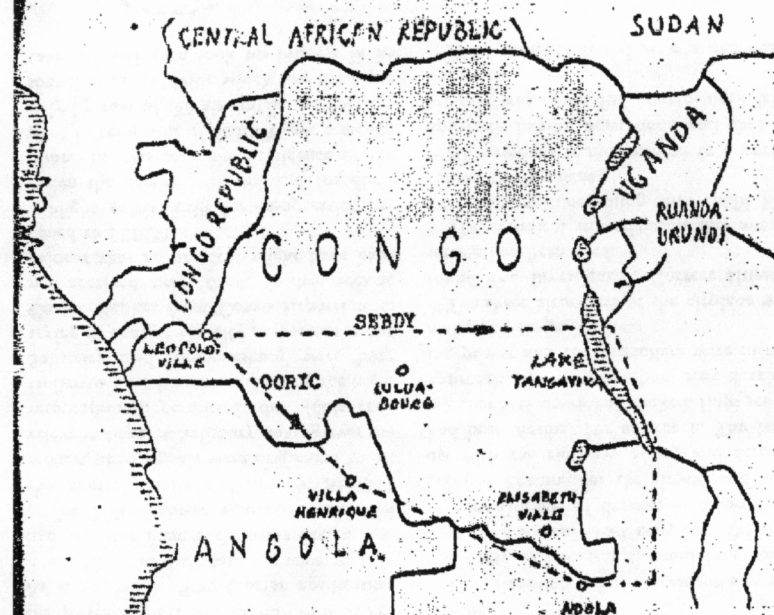
FIG. 1

OORIC	SEBDY	
Departure Léopoldville	1504	1551	GMT
Arrival Ndola	2035	2210	GMT
Flight time	5:31	6:19	Hours: Minutes
Distance flown	1120	1735	Miles

parture Léopoldville. Later it reported being over Lake Tanganyika. Neither Salisbury nor Ndola had received any advance information about this aircraft which two hours later arrived over Ndola coming from the east. SEBDY departed Léopoldville 45 minutes later than OORIC and arrived over Ndola 1 hour and 35 minutes after the landing of OORIC. Although it was 30 % faster, SEBDY used 15 % longer flight time. The route taken by SEBDY has been reconstructed and is shown — compared to that of OORIC — in fig. 1. It is to be noted that SEBDY flew through Nairobi Flight Information Region without reporting this to Nairobi.

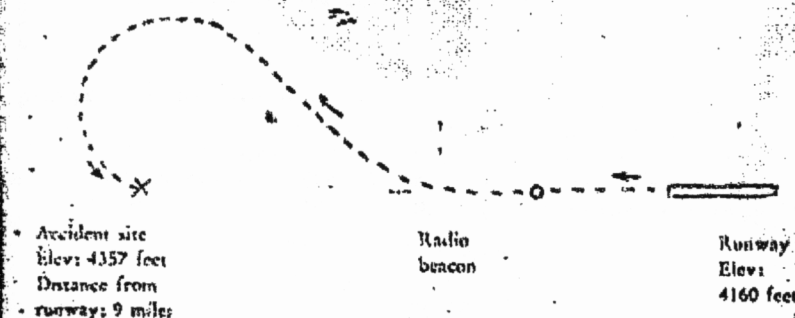
It was found that SEBDY had passed over Ndola, coming from the east, heading for the radio beacon two and a half miles west of the field. It had then made a right turn, to a north-westerly heading, and after flying in this direction for a while made a left turn. SEBDY flew in a pattern similar to the instrument let-down procedure of Ndola (see fig. 2).

After passing the airport the aircraft was headed out over an uninhabited, completely black area with no ground references.

Soon after starting the left turn the pilot gets the runway in sight and tries to estimate the distance to it. During daylight or if flying over a lighted area this may very well be done. But as the conditions were at Ndola the terrain below and between the aircraft and the runway was in complete darkness. Under such conditions it is impossible to judge the distance with any degree of accuracy. If descent is started the altitude should be decreased with decreasing distance to the runway. And under the above related circumstances it was quite impossible to judge the height.

During the turn he got the runway in sight. The conditions were ideal for an optical illusion. A contributive factor may have been that the Ndola runway is very narrow. Deceleration in forward speed and acceleration downwards due to the turn contributed to a complete sensory illusion which made the captain believe that he was too high. He ordered "Flaps 30", kept the power setting low and went into a descent of more than 1000 feet per minute. The co-pilot being overstressed failed to check the altimeter and went on with the check list. The captain, eyes on the lights, lessened the turn to line up the aircraft with the runway. Being satisfied that he was now on correct glide path he increased power. Keeping the correct approach speed he hereby raised the nose of the aircraft, and thus, still being the victim of an optical illusion, the captain thought that the aircraft was fully safe when it descended into the ground.

In this situation a careful pilot would have asked for a clearance to return to the

field in order to make a normal landing circuit. He would no doubt have been cleared accordingly and told to report on down-wind leg. He would then have made a left turn back to the field, arrested the descent at 6000 feet and let the speed drop off. When circling the field he would have lowered the altitude to circuit height — field elevation plus 1200 feet — in this case 5400 feet. He would have positioned the aircraft on down-wind leg parallel to the runway flaps set at 20 degrees maintaining a speed of 140 knots. When abeam the runway end he would have lowered the landing gear, soon afterwards starting a descending left hand turn down to the runway. This is the most simple and safe method of approach there is and every pilot is trained in it. The crew would have had plenty of time to prepare itself for the landing and the final approach would have been made close to the runway thus greatly eliminating the risk of erroneous judgment in height.

Other pilots would have asked for a clearance to make an instrument approach. When passing the radio beacon they would have turned 45 degrees right to a north-westerly heading. After 45 seconds they would have started a left hand turn back to the field. During the procedure they would have stopped the descent at 6000 feet and let the speed drop off. At 165 knots flaps would have been set to 20 degrees. After the turn back the correct moment to start final let down would have been judged by observing the runway lights. The descent would have been started by lowering the landing gear, the aircraft would have been lined up with the runway and the altimeters carefully checked during final approach. During the procedure turn the aircraft would have been as far away from the field as 8 to 9 miles.

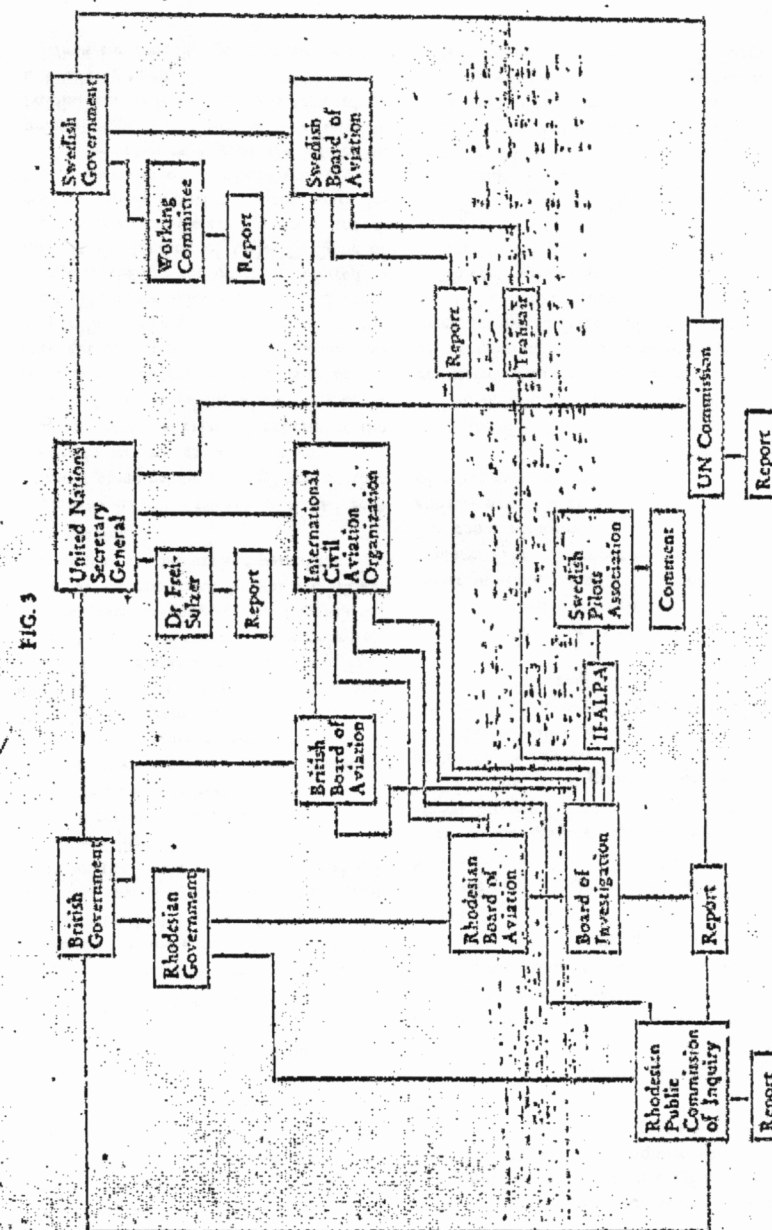
The different authorities that dealt with the Ndola accident as well as the commissions and their reports are shown in fig 3. The UN commission consisted of persons from Sweden, Yugoslavia, Sierra Leone, Nepal and the Argentine.

were attached to it. This body of technical and operational experts made the investigation and prepared a report that was the basis on which the hearings were made before the Rhodesian Public Commission of Inquiry and the UN Commission.

The Board of Investigation worked on four theories that had been laid down beforehand, i.e. enemy action, sabotage, technical malfunction and pilot error. By discussing the first three of these theories and concentrating all work on them they were eliminated, and pilot error was indicated as being the cause of the accident.

It is the first time an accident investigation has been treated this way which becomes disastrous when the different theories appear again in a summing up. It was certainly so in this case as the possibilities for pilot error were not discussed and the operational data with a bearing on pilot error were missing.

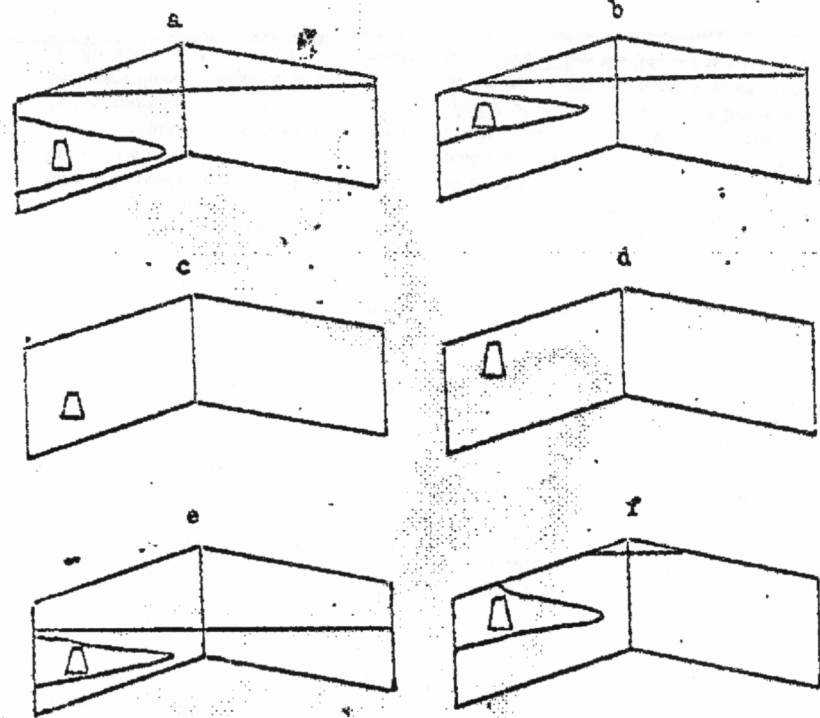
FIG. 4

A runway situated on a tongue of land is seen through the cockpit windshield of an aircraft approaching over the water under different conditions. The distance to the runway is in all instances the same — about half a mile.

In c) and d) the approach is made during night. There is no horizon and no land

contours. Only the lights forming the runway can be seen. It is then plausible to assume that the aircraft is on correct glide-path in c) and too low in d). The conclusion is arrived to by imagining the horizon and put it at the same place as in a) and b). It is kind of a second nature with pilots to imagine where the horizon is when it cannot be seen.

As can also be seen from fig. 4 the runway contours give different perspectives depending on which height it is seen from. This is a condition that is used by many pilots. They carry in mind a picture of the contour the runway should form when seen from the ideal glide-path.

The farther away one is from the runway the more difficult it is to judge the correct glide-path. The error in height caused by misplacing the horizon increases with increasing distance from the runway. A one degree misplacement of the horizon means less than 50 feet error in height at a distance of half a mile — as in fig. 4. At 9 miles distance — as at Ndola — it means 825 feet error in height.
